INSTALLATION GUIDE

**AGILE
OFFROAD**
SMARTER THAN DIRT®

POWER STEERING REPAIR HOSE KIT

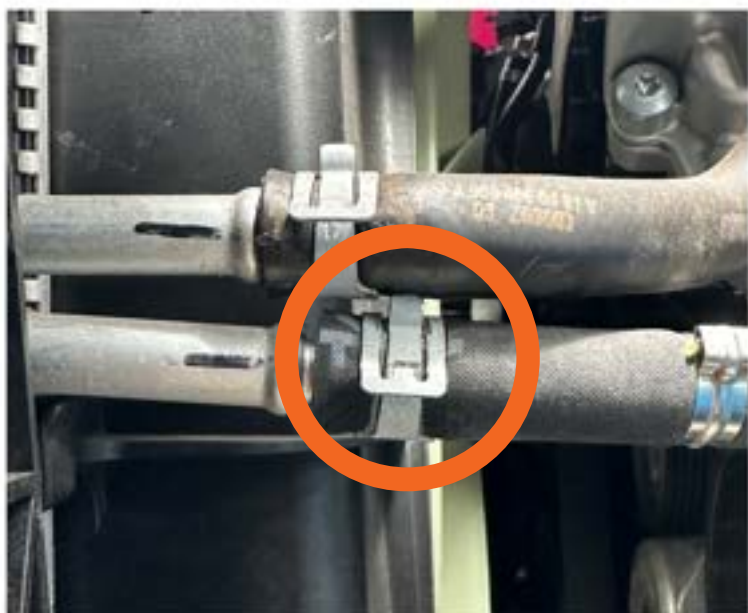
The power steering lines are located on the driver side of the radiator. The lower line is the return/low pressure line.

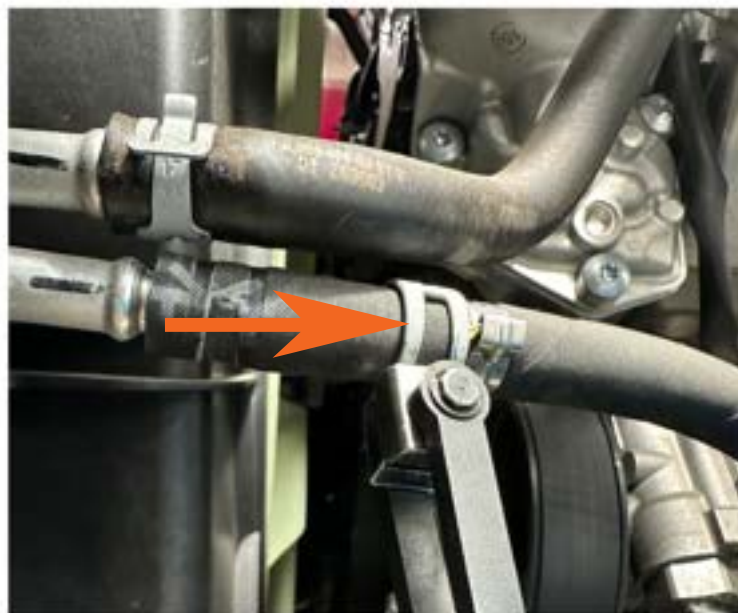
Use clamp pliers to slide clamp back as shown.

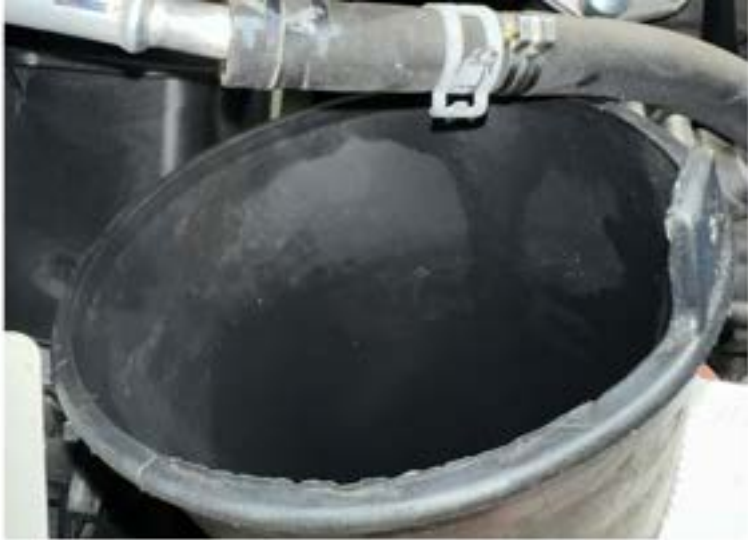
Place funnel below power steering hose and through van subframe.

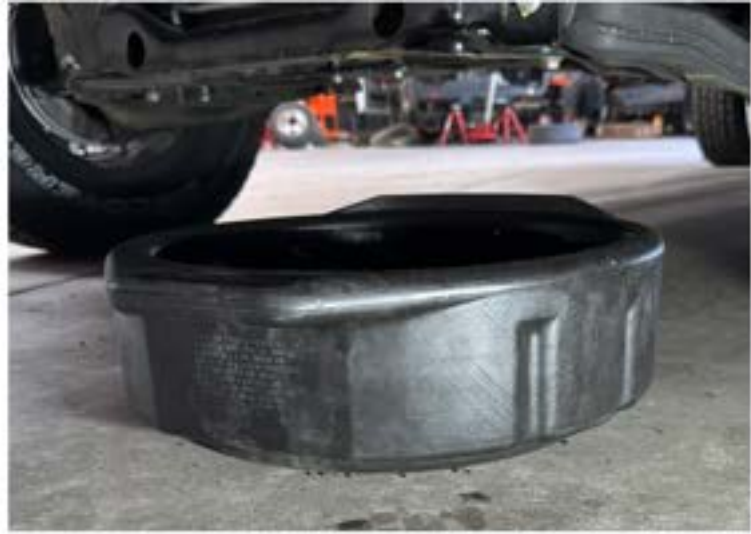
Place oil pan under van and below funnel end.

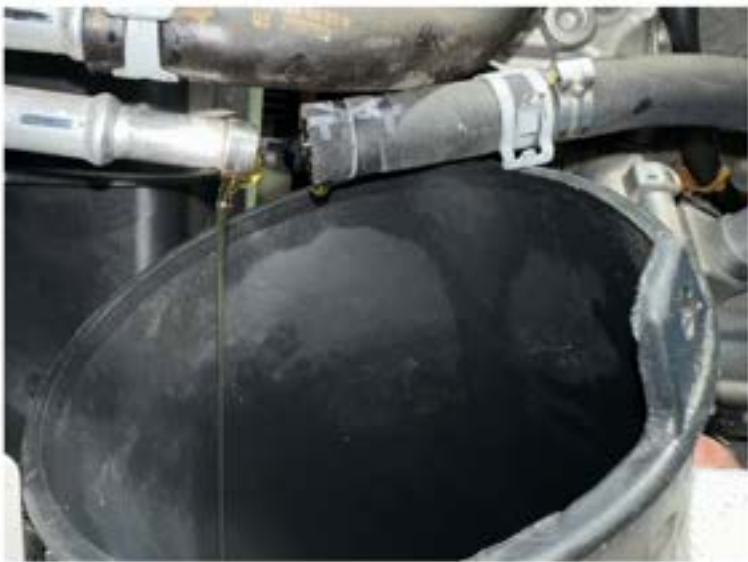
Pull power steering hose from cooler port.

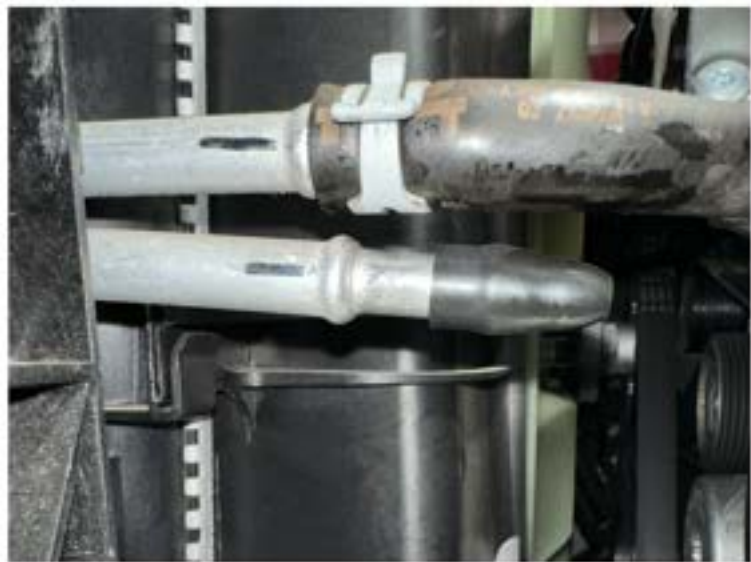
Quickly install supplied rubber line cap to cooler port to stop power steering fluid from draining.

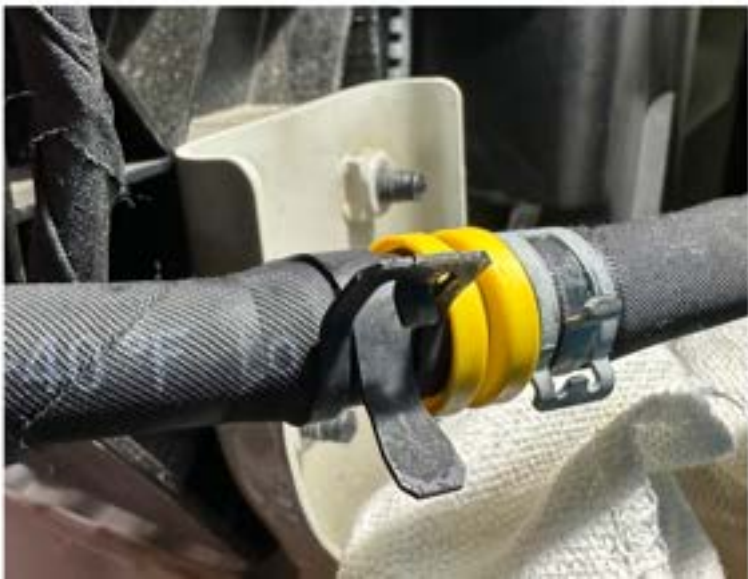
Install the new AO hose with barb fitting end onto the factory power steering hose as shown. Use clamp pliers to position the factory and the supplied band hose clamps as shown.

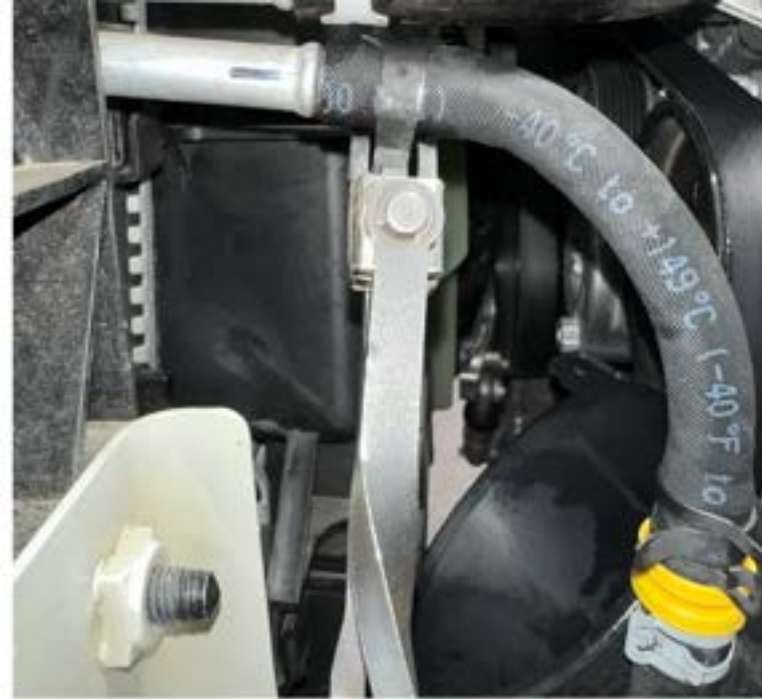
Remove rubber line cap and install the open end of the AO hose onto the cooler port using the supplied band hose clamp.

A worm drive hose clamp is supplied as an alternative to the band clamp.

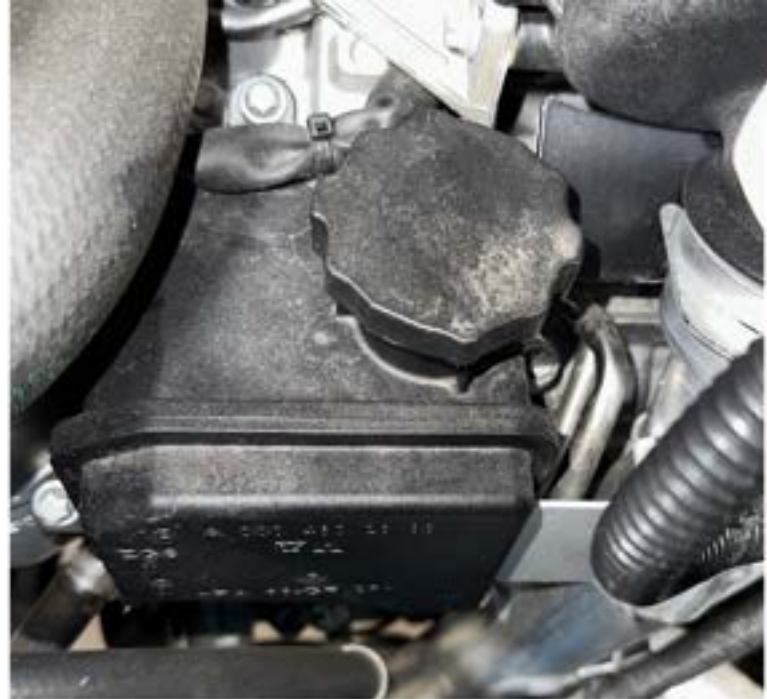
Locate the power steering fluid reservoir.

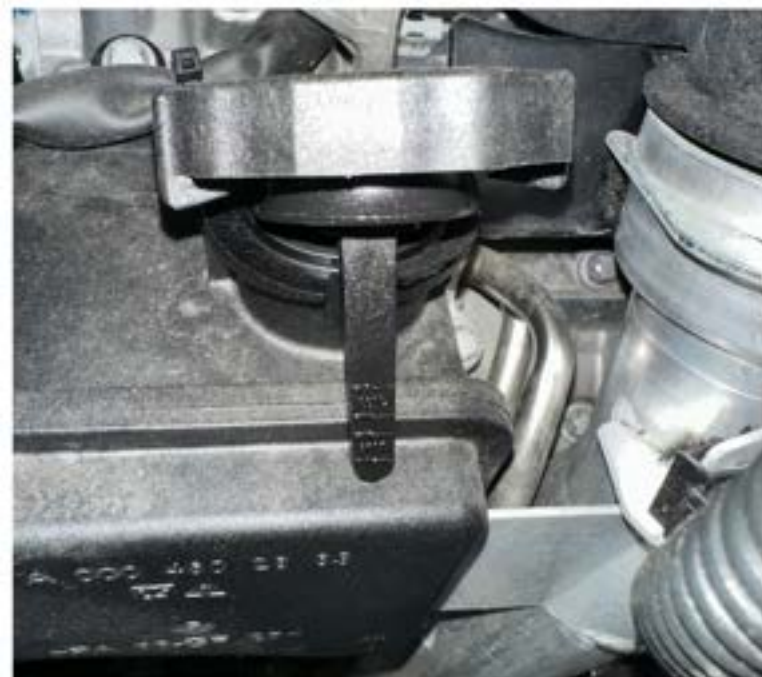
Turn on the engine and cycle the steering lock to lock several times. Turn off engine and check the power steering fluid level. Add fluid as necessary. Use only Mercedes recommended 345.0 spec or better.
